Australian Timber Flooring Association Information Sheet: 31 January 2011

Information for floor installers and owners of timber flooring

This information is provided for guidance when a timber floor has been inundated with silt laden water typical of what has occurred in Queensland in January 2011. It does not apply to inundation from sea water.

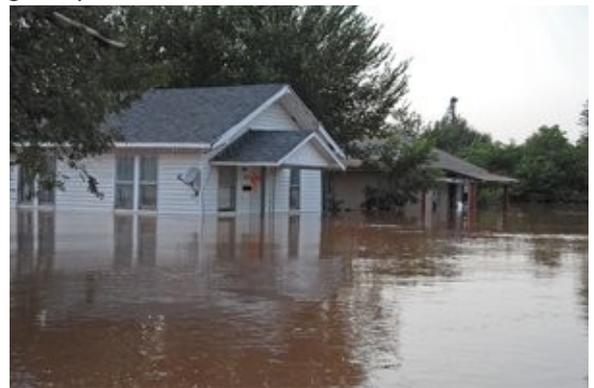
Where the flooring has been laid on sheet structural subfloors of particleboard or plywood it is unlikely that the floor will be recoverable, although even if the floor is not recoverable it may be possible to recover the sub-floor. In either situation it is still necessary to remove the mud and silt as quickly as possible and due to the inundation that has occurred, it is appropriate to hose clean and then use a wet and dry vacuum cleaner to remove remaining surface water. In the much, less likely situation of trying to retain the floor, dehumidifiers may then be used to provide gentle but consistent drying above the floor.

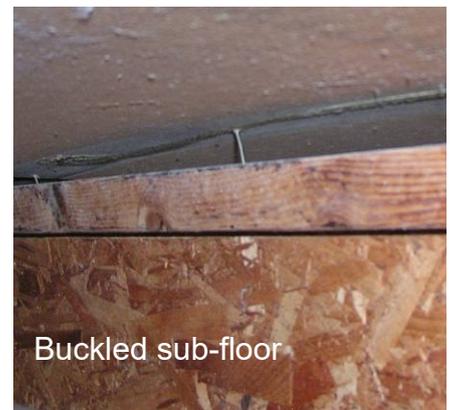
Particleboard in particular where retained is likely to swell at board edges and as such the subfloor needs to be prepared correctly prior to the laying of the new floor. Adhesives require clean dry surfaces and therefore to provide this and remove any swelling at sheet edges the subfloor should be completely rough sanded. If there are any underlying concerns with adhesion then tests can be undertaken. Test pieces, of the flooring to be used, that are about 400 mm long and with adhesive over half their length, can be used in various areas, left 24 hours and then lifted to test the adhesion. Industry laying recommendations for timber floors over sheet subfloors should be referred to.
